On June 19, 2000, a flow investigation was performed at the Southwestern Electric Power Company (SWEPCO) Pirkey Power Plant, permit 02496.000 in Harrison County. Specifically, upstream tributaries to outfalls 004-006 and Hatley Creek were investigated for flow status, persistent pools, general conditions, etc. Tributary and outfall locations at the plant are different from the generalized map sent to the region (which was probably taken from the permit). The diagram in Figure 1, page 1, attempts to more accurately represent actual conditions (see comments for outfall 004, below). Stream conditions on 06/19 are thought to represent baseline conditions. Rainfall for June was recorded on 06/09/02 (0.89") and 06/16/02 (0.07"). Flows, when possible, were taken as well as photographs of the tributaries. Photographs of Hatley Creek upstream of the SWEPCO facility are included for perspective. Findings are listed below with a diagram and photographs following. A copy of the facility map is attached following the figures.

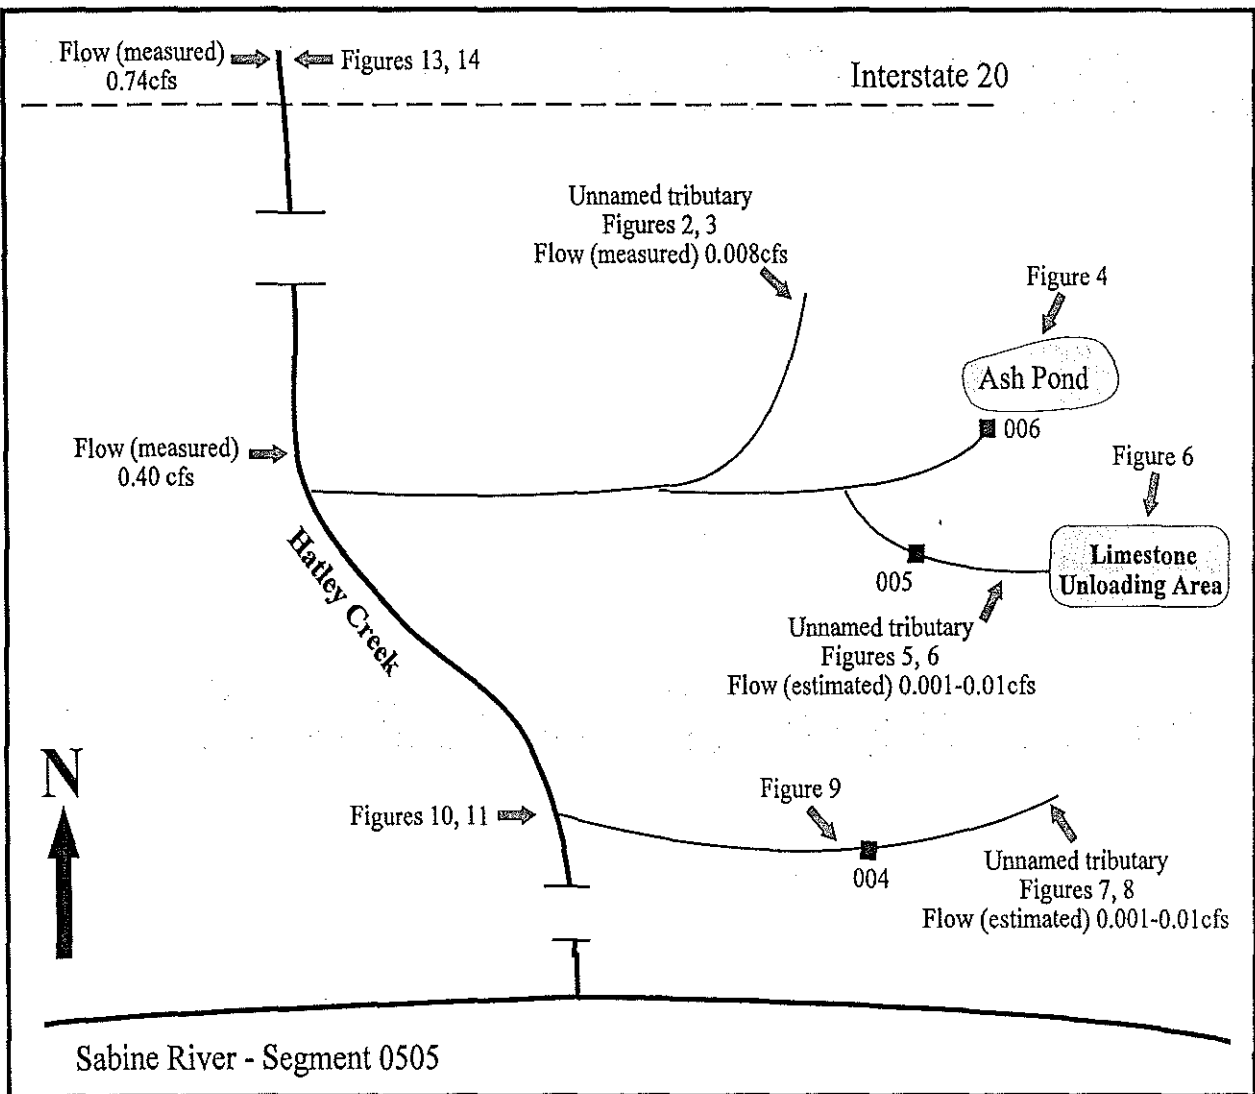
■ **Tributary above Outfall 004:** Unlike the map submitted to the region, outfall 004 does not join the same unnamed tributary on which outfalls 005 and 006 are located. Rather, outfall 004 is the sole outfall on a tributary which originates south of the tributary on which 005 and 006 are located (see Figure 1). The tributary on which 004 discharges is a very shallow (< 3 cm deep), narrow (0.5-0.7 m wide) stream with very little flow. Flow was estimated at 0.001-0.01 cfs. No evidence of pools, trenched areas, or depressions to serve as pools were noted in the stream bed. Figures 7 and 8 show the unnamed tributary above outfall 004.

Figure 1. Generalized layout of outfalls 004-006 in relation to one another and Hatley Creek.
Note: Layout **NOT DRAWN TO SCALE**

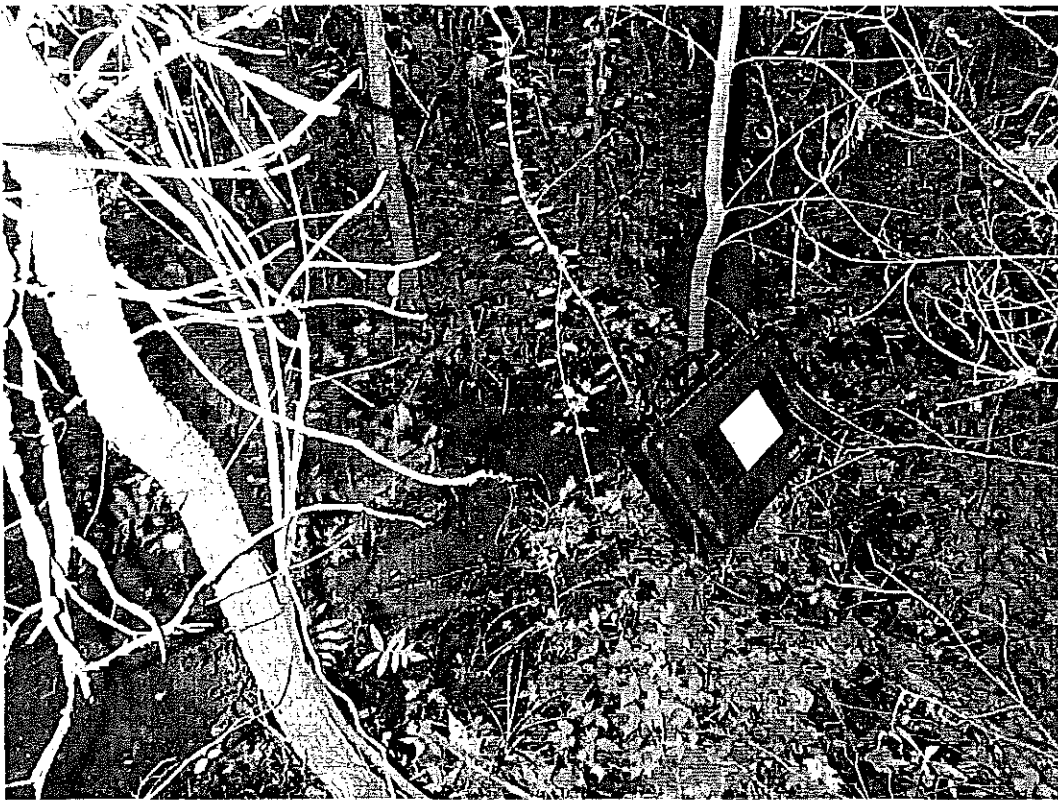
■ **Tributary above Outfall 005 and 006:** This tributary is shown in Figures 2 and 3. Due to the shallow nature of the stream, flow was measured by clearing sediment and making a small straight channel. Flow was measured at 0.008 cfs. The tributary had no evidence of pools nor deep depressions suitable for aquatic life other than macroinvertebrates.

Figure 2. Unnamed tributary approximately 35m above confluence with outfalls 005 and 006. See Figure 1 for diagram of tributary location. Measured flow of tributary = 0.008 cfs. No pooling was noted.

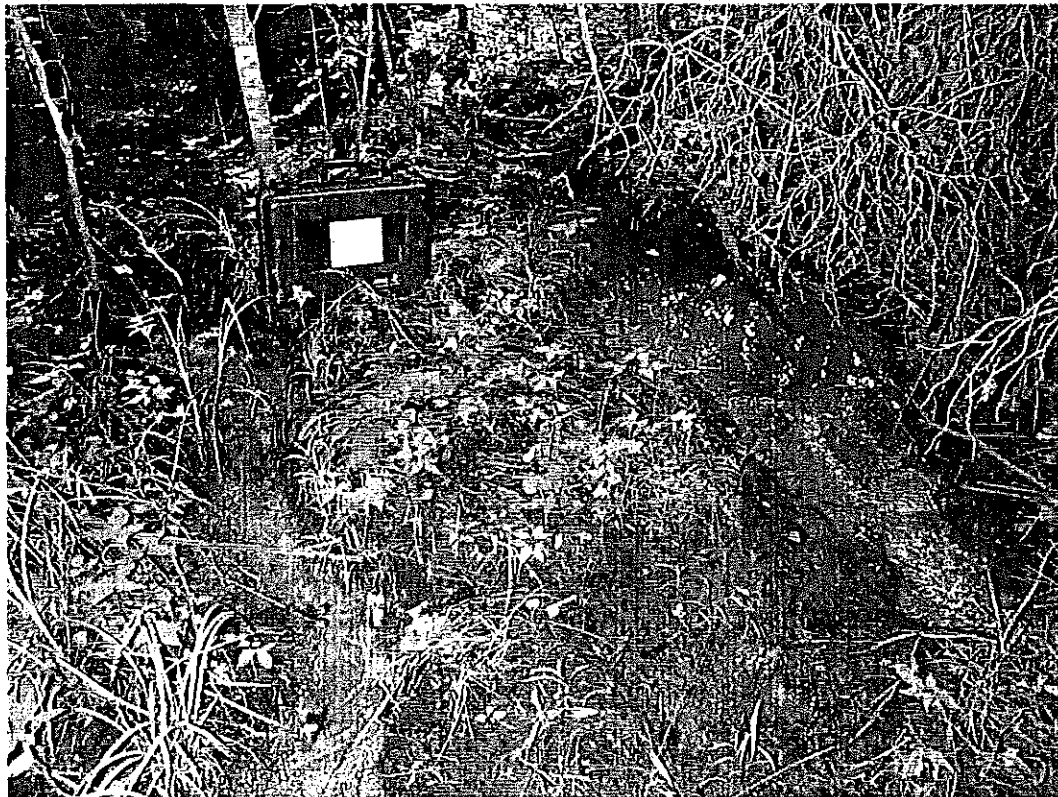
Figure 3. Second picture of unnamed tributary approximately 42m above confluence with outfalls 005 and 006. See Figure 1 for diagram of tributary location. Measured flow of tributary = 0.008 cfs. No pooling was noted.

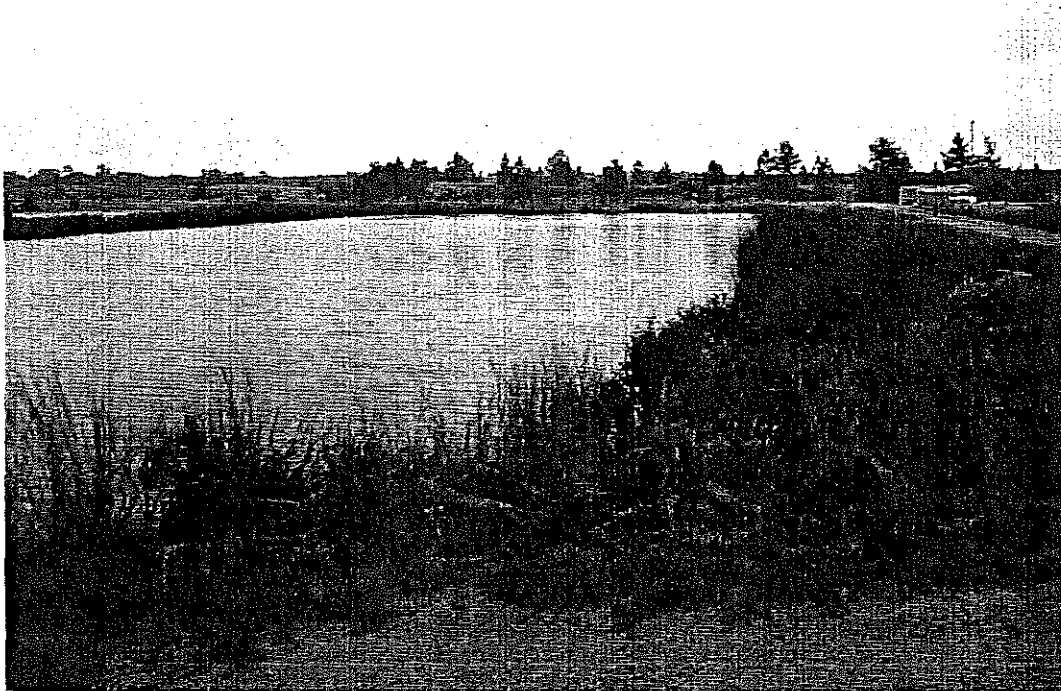
■ **Tributary above Outfall 006:** A flow status was requested above outfall 006, which is the outfall for the ash pond (Figures 1 and 4). If, in the past, a tributary existed in this area, it has now been inundated by the ash pond. There did not appear to be a tributary feeding into the pond, therefore, no flow was noted above outfall 006.

Figure 4. Ash Pond. Location of ash pond is directly above outfall 006. See Figure 1 for diagram of ash pond location.

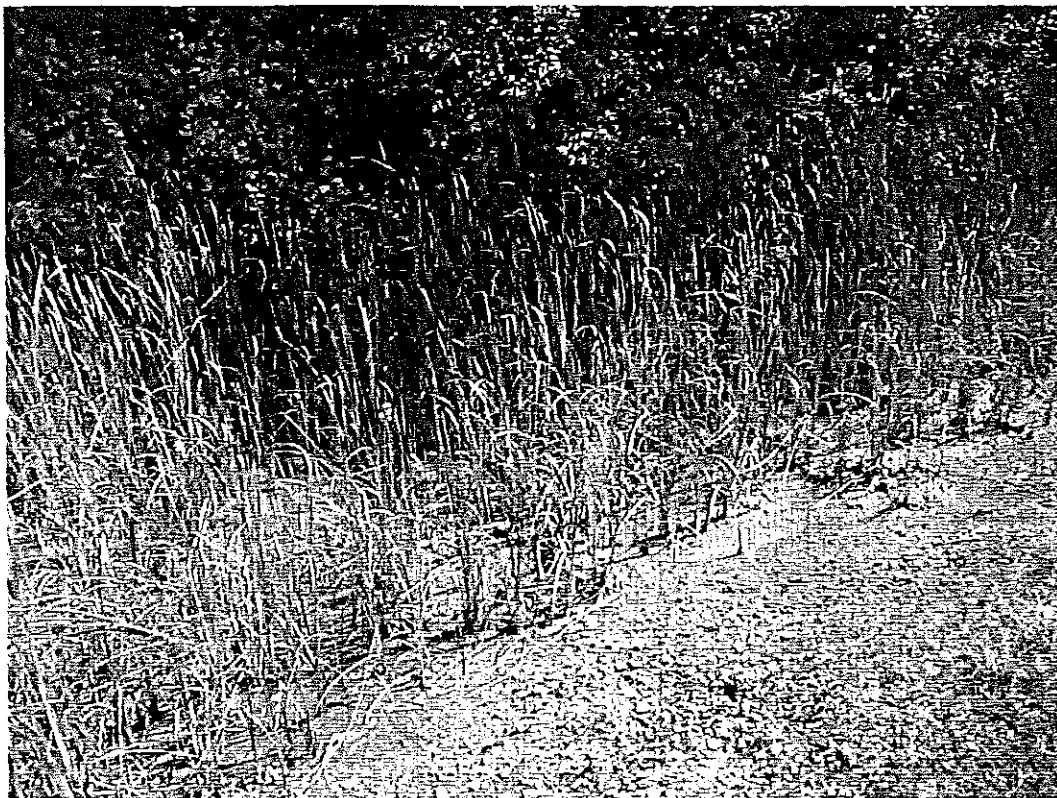
■ **Tributary above Outfall 005:** The tributary above outfall 005 is a narrow (0.4-0.5 m wide), shallow (<3 cm deep) stream which appears to originate from a seep in what is now the limestone unloading area (Figures 1, 5, and 6). Flow was estimated at 0.001-0.01 cfs. There are no pools or depressions in the stream bed. Immediately upstream of the outfall structure, the stream flows into a small man-made basin before leaving through outfall 005. This basin serves as the limestone runoff pond. The basin contains shallow standing water and is inundated with cat tails and other aquatic and semi-aquatic vegetation. The basin does not appear to offer appropriate fish habitat.

Figure 5. Unnamed tributary approximately 40m upstream of outfall 005. See Figure 1 for diagram of tributary location. No pools present.

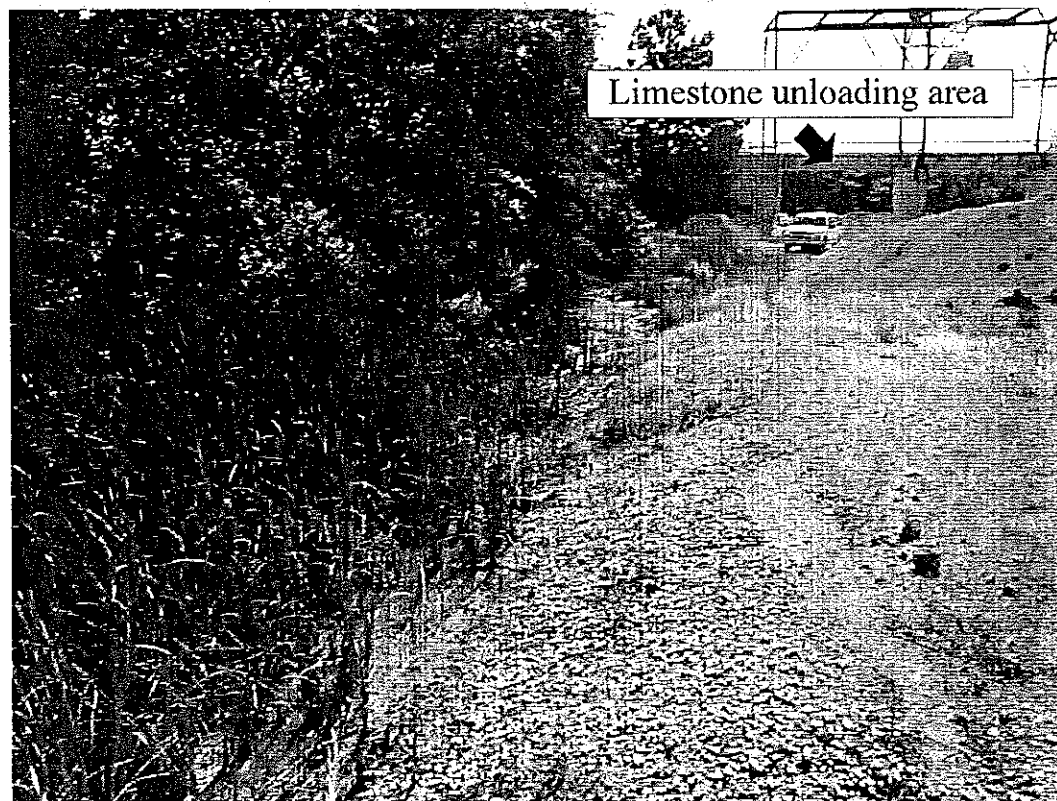
Figure 6. Unnamed tributary approximately 70m upstream of outfall 005. Tributary begins in the limestone unloading area. See Figure 1 for diagram of tributary location. No pools present.

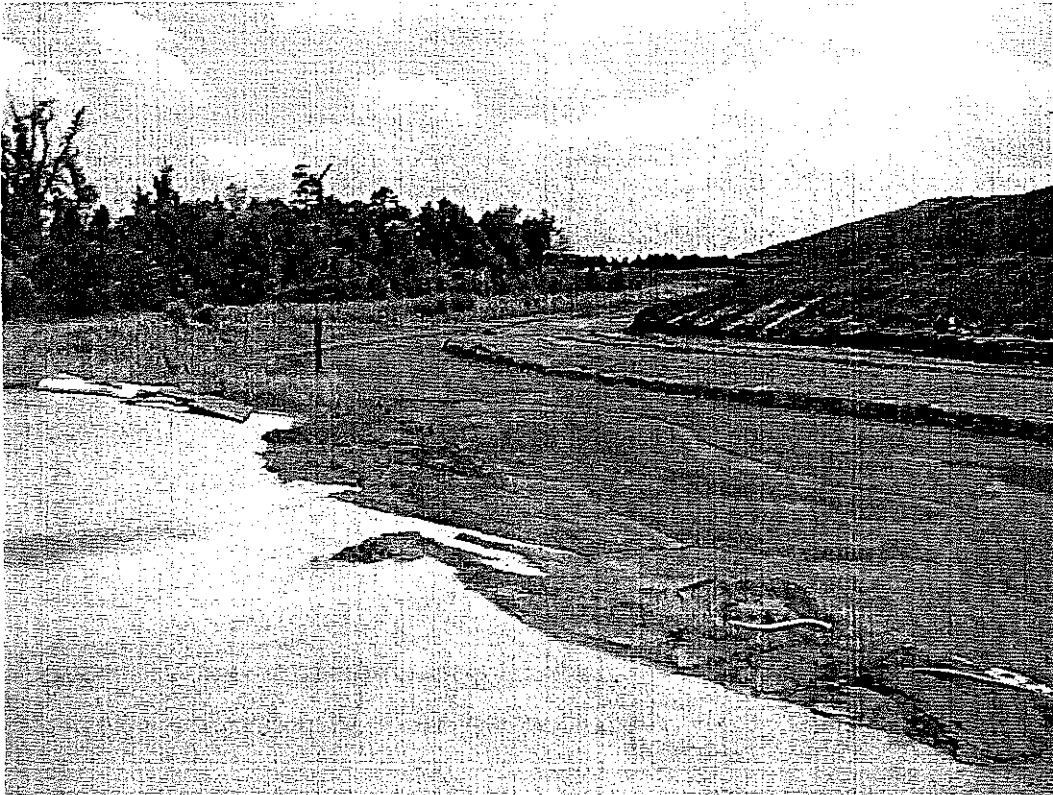
Figure 7. Unnamed tributary approximately 30 m upstream of outfall 004. No pools present. See Figure 1 for diagram of tributary location.

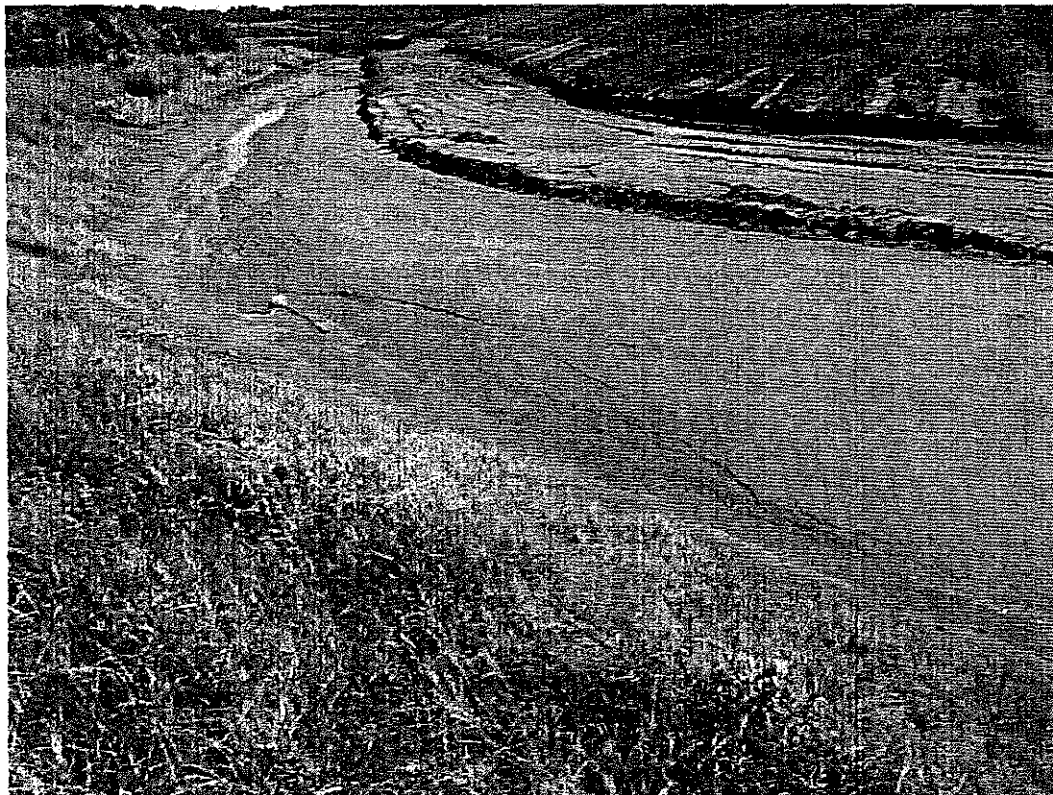
Figure 8. Unnamed tributary approximately 35 m upstream of outfall 004. No pools present. See Figure 1 for diagram of tributary location.

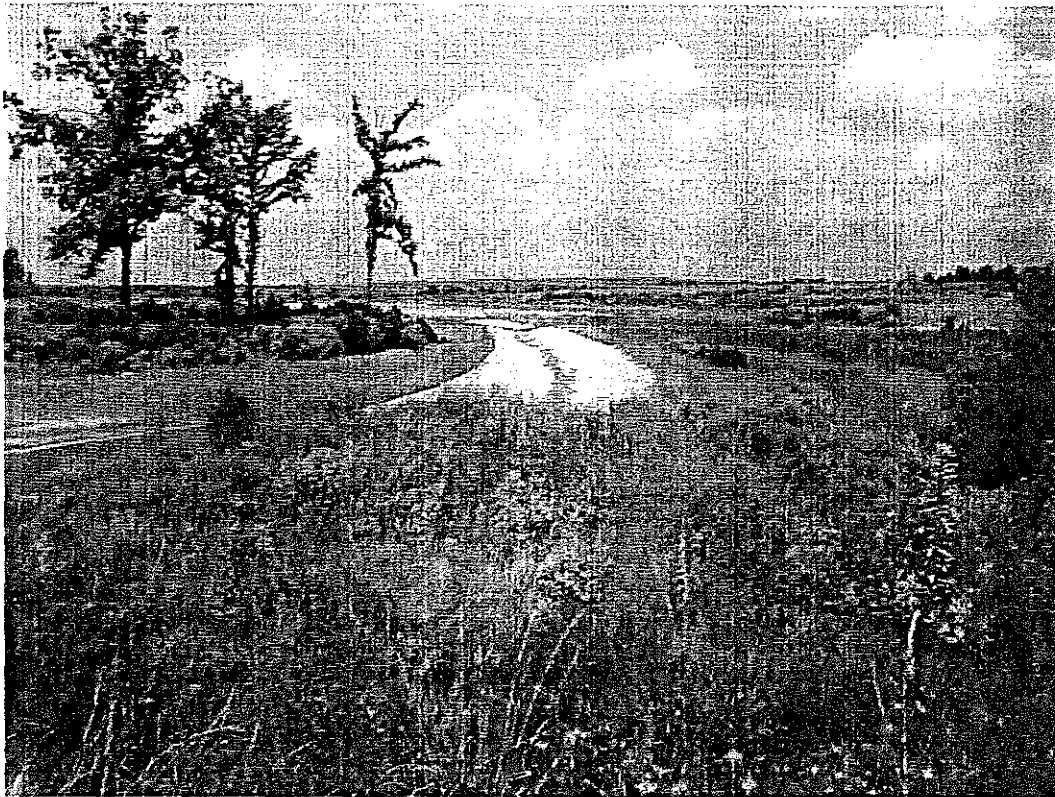
Figure 9. Unnamed tributary immediately below outfall 004, several hundred meters above confluence with Hatley Creek.

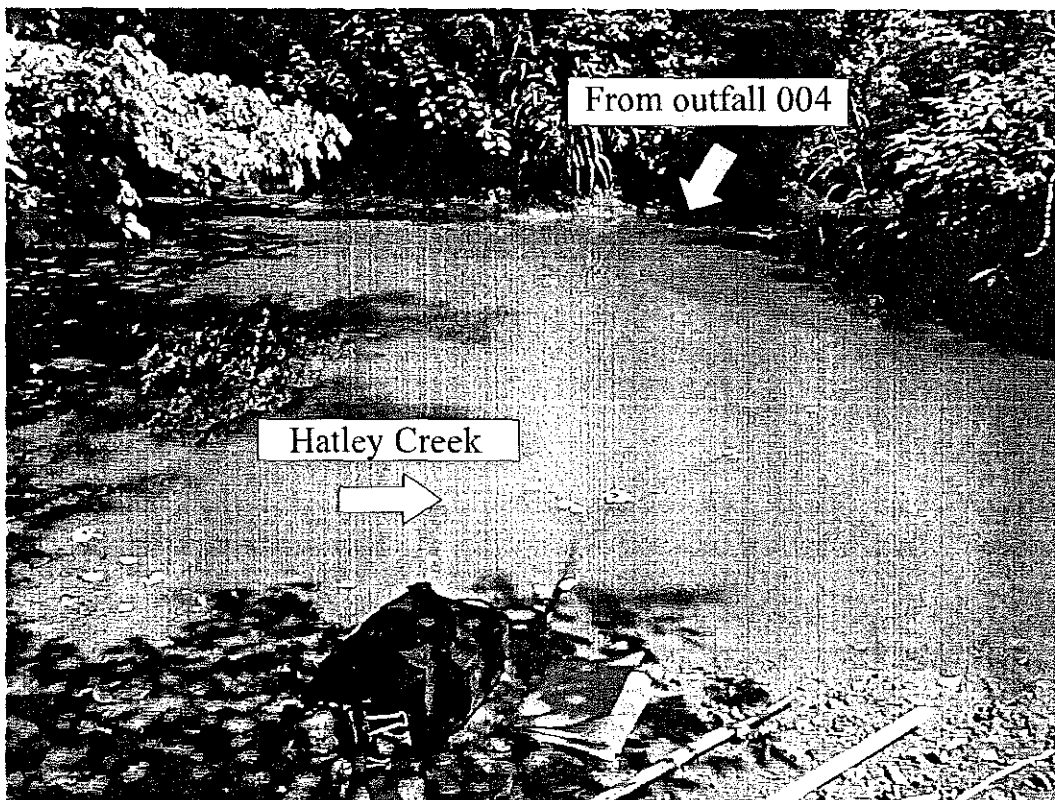
■ **Hatley Creek:** The stream above the outfalls had a measured flow of 0.40 cfs. An additional flow, upstream of the SWEPCO property at I-20, was measured at 0.74 cfs. Hatley Creek had several large pools suitable for fish (Figures 10-12). Figures 13 and 14 were taken on Hatley Creek at I-20 on 06/25/02 and are included as supplementary information.

Figure 10. Confluence of outfall 004 with Hatley Creek.

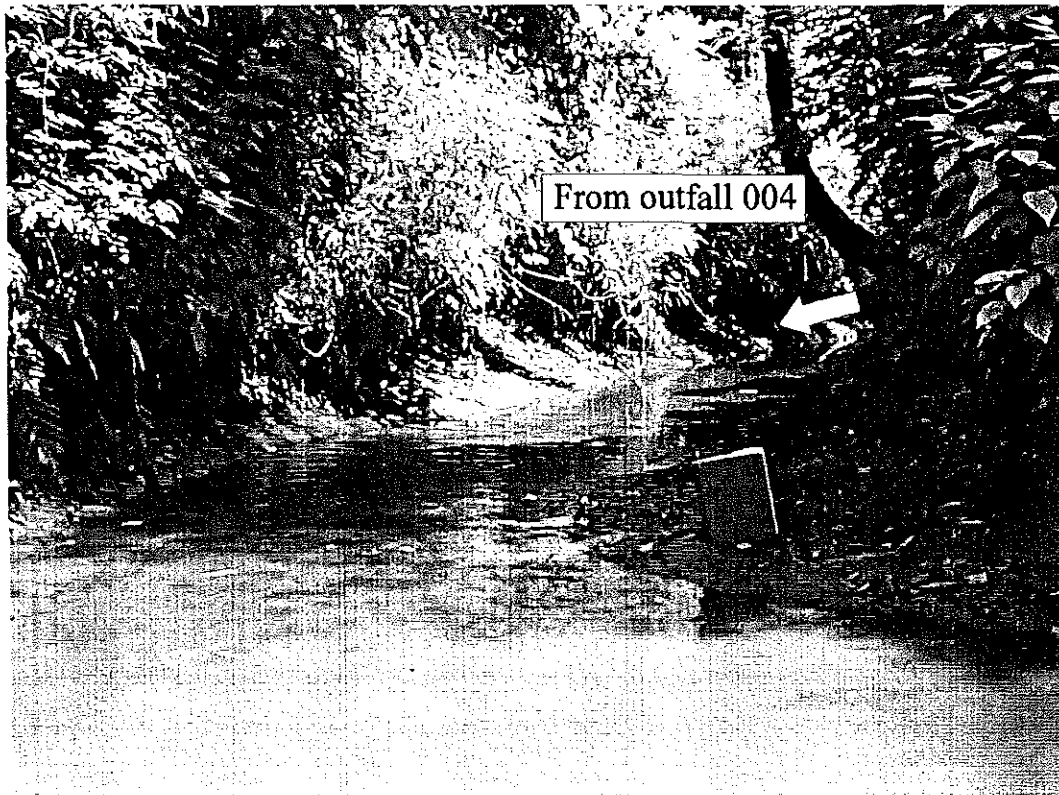
Figure 11. Confluence of outfall 004 with Hatley Creek.

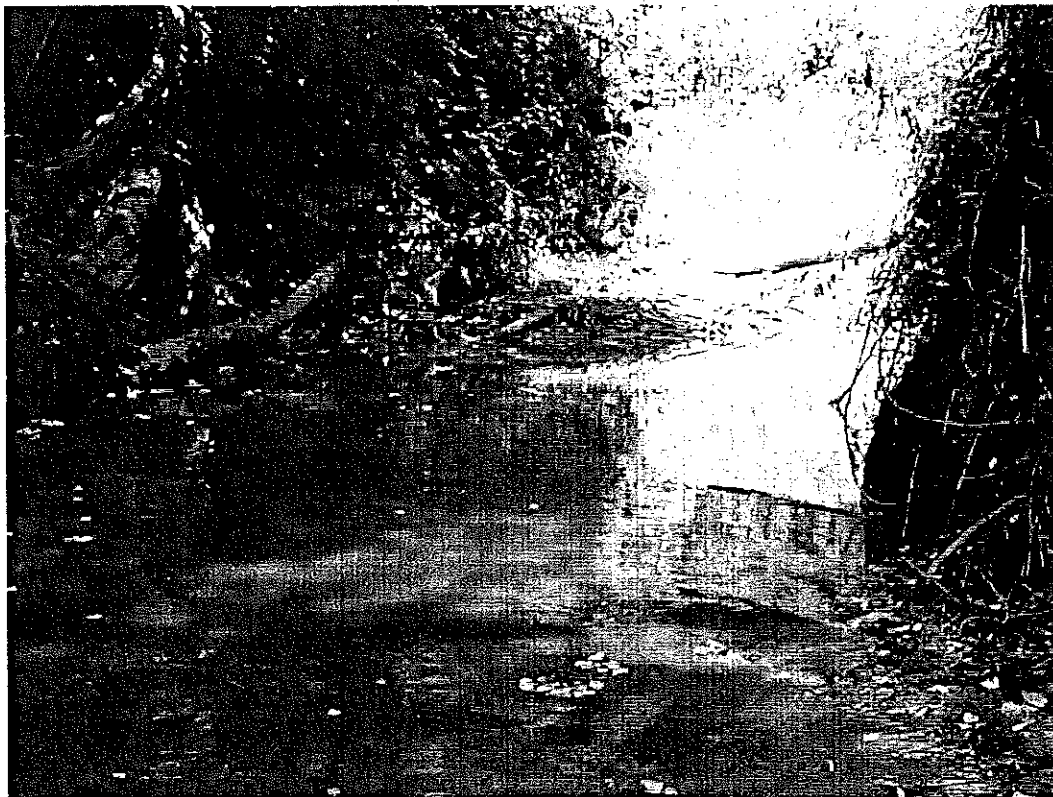
Figure 12. Pool habitat in Hatley Creek upstream outfalls. Pool dimensions were 11m (w) x 14m (l) x 1.1m (d). This type of habitat was common in Hatley Creek.

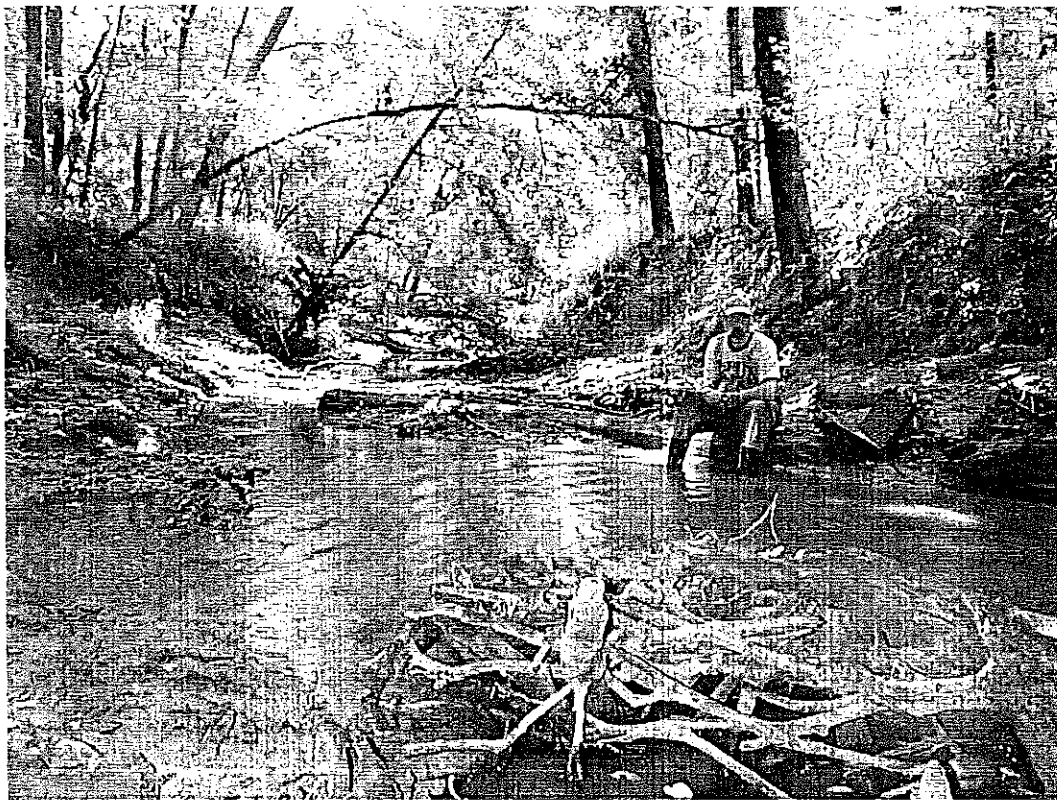
Figure 13. Hatley Creek upstream of I-20. See Figure 1 for diagram of location. *Picture not taken on SWEPCO property but included to show characteristics of Hatley Creek upstream of SWEPCO.*

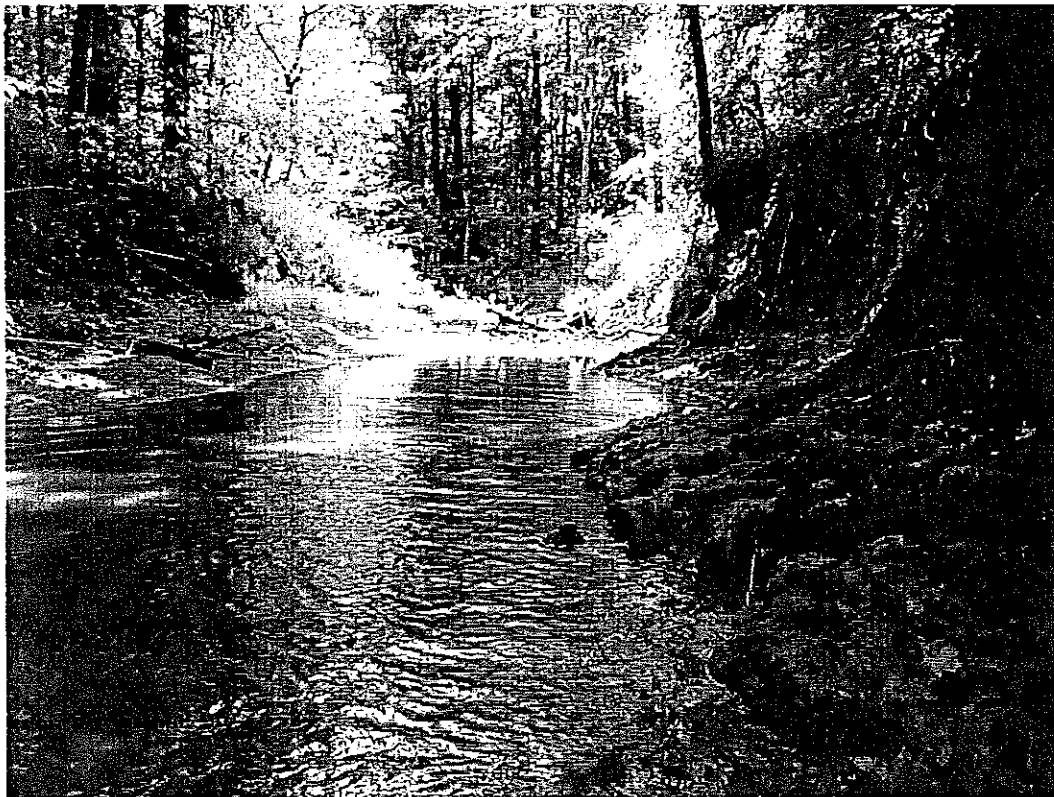
Figure 14. Hatley Creek upstream of I-20. See Figure 1 for diagram of location. *Picture not taken on SWEPCO property but included to show characteristics of Hatley Creek upstream of SWEPCO.*
